Technical Bulletin

This Technical Bulletin explains the replacement of the incorrect product label on a PDI-508 series suspension arm. This effects units manufactured before May 16, 2003.

PDI-508W-LCD-13 Support Arm Product Label Replacement

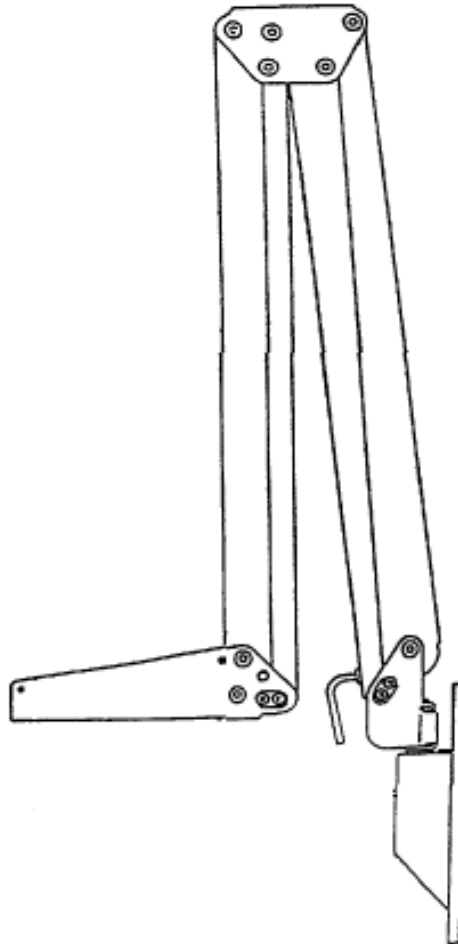
All PDI products come with a product label identifying the product. Unfortunately, during a production run of support arms, an incorrect and outdated label format was used on the LCD version of the 508 series support arm.

The product label is located on the base of the arm directly above the pivot pin. Note, if the arm is installed in a wall mount the pivot pin will not be visible. The incorrect label will bear the model number PDI-508W-LCD-13, show a date of manufacture before May 16, 2003 and also be missing the UR Underwriter Laboratories recognition mark.

Remove the suspect label and replace with the revised label. Contact PDI for a replacement label. NOTE: Each replacement label is serialized and requires a "one-for-one" match with the original serial number as it appears on the label when replaced.
